WOOD-DESTROYING ORGANISMS INSPECTION REPORT

123 Main Street
Your City, Florida

Report ID # 18394

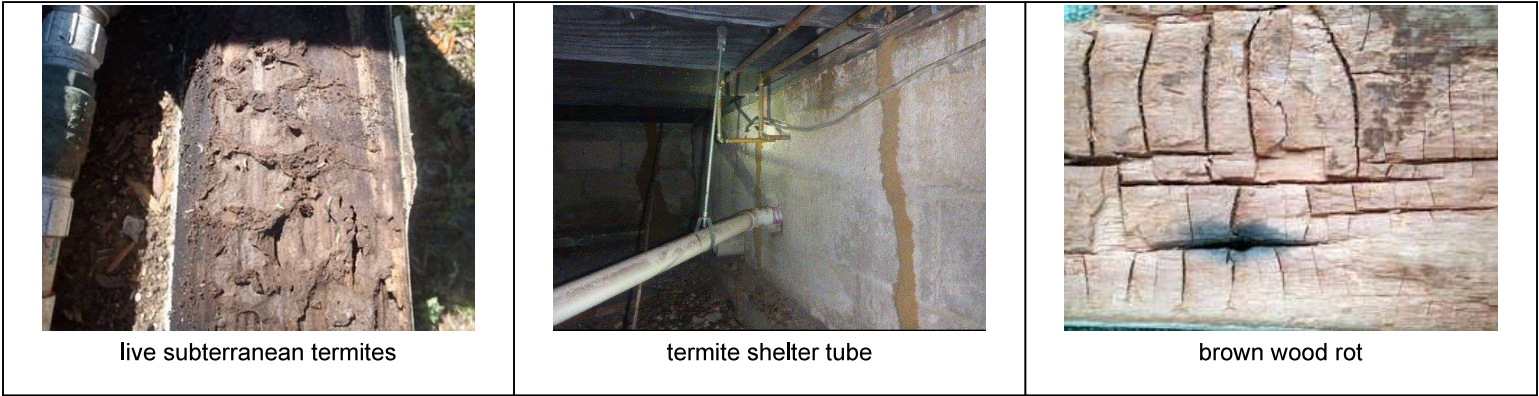
Comments:

Comments: (Use additional pages, if necessary)
Live Eastern Subterranean termites were observed in the crawlspace beneath the master bath.
Brown wood rot is present in the door trim at the garage and in the fascia at the front left of the home.
Recommend treatment for subterranean termites and brown wood rot.
